## Basalt Linings Solve Cyclone Wear Problems

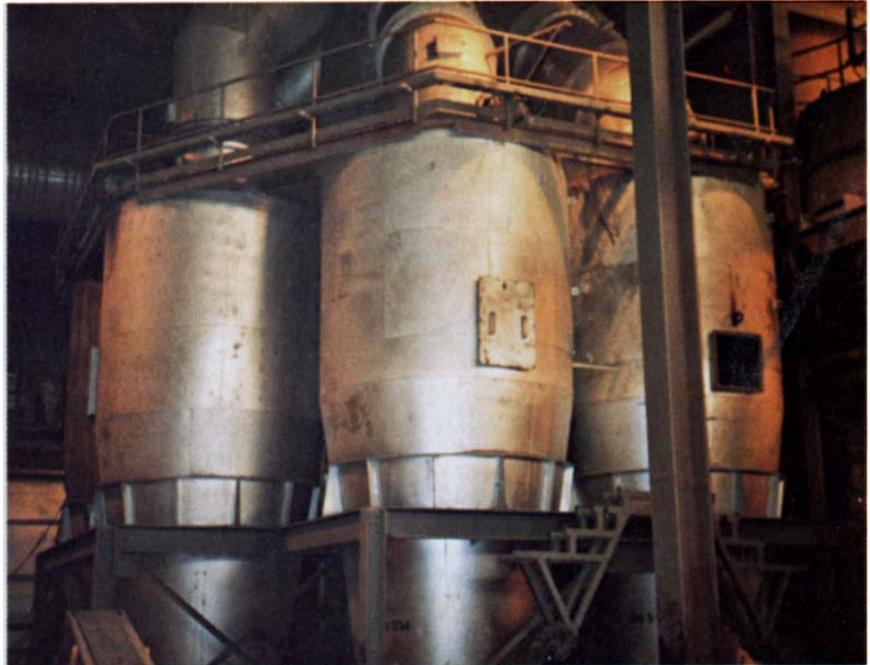
*Three of the six cyclones at the Canada Cement Lafarge facility that have withstood abrasive effects of limestone and shale clinker after being lined with basalt ceramic lining.*

Custom-shaped tiles of the fused cast basalt were set in a mastic mortar inside the six cyclones, each over 36 ft tall and 10 ft diam.

Installation of the ceiling tiles by a seven-man construction crew involved fusing a metal bar into the back of each tile and then welding the bar to the cyclone's inner surface. This attachment method was used to completely isolate the support system from abrasion. The method also was used because of weight and gravity considerations to produce a more secure hold on the ceiling's surface as opposed to using adhesives only.

"Since the installation in early 1986," said Sato, "there has been no downtime at any of the six cyclones, and company officials are considering lining eight other cyclones in the same way this year." Estimated life for the basalt linings is 20 years, with a manufacturer-claimed cost recovery period of about four years.
